# Backgrounder on the Three Mile Island Accident

The Three Mile Island Unit 2 reactor, near Middletown, Pa., partially melted down on March 28, 1979. This was the most serious accident in U.S. commercial nuclear power plant operating history, although its small radioactive releases had no detectable health effects on plant workers or the public. Its aftermath brought about sweeping changes involving emergency response planning, reactor operator training, human factors engineering, radiation protection, and many other areas of nuclear power plant operations. It also caused the NRC to tighten and heighten its regulatory oversight. All of these changes significantly enhanced U.S. reactor safety.

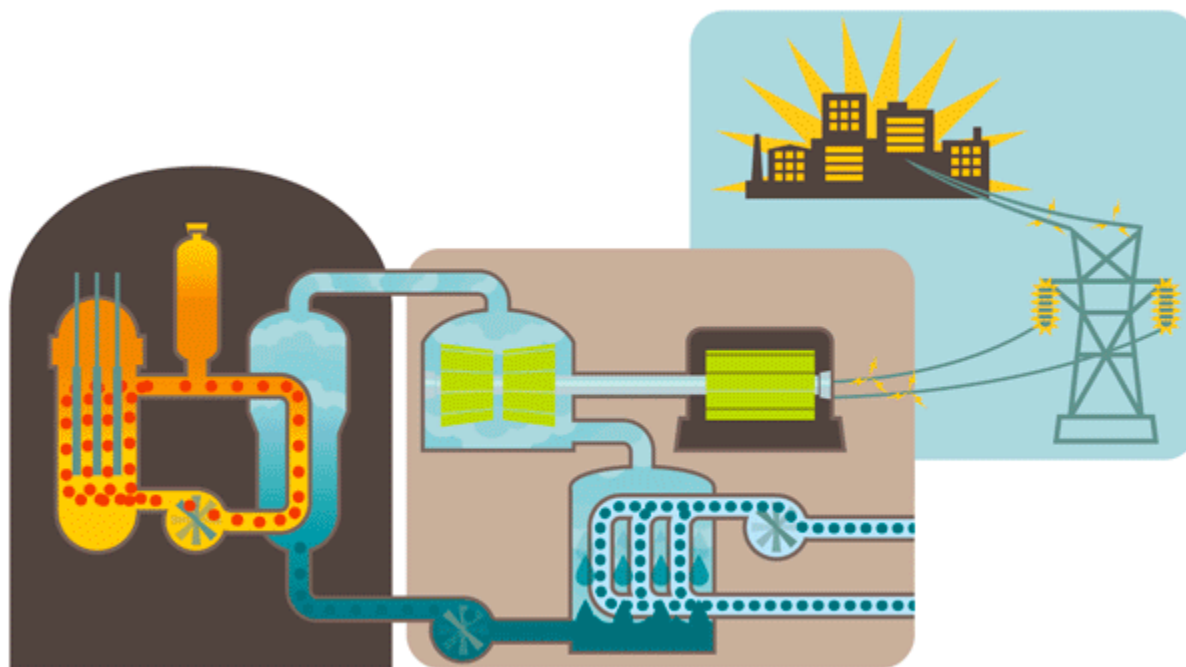
## Animated Diagram of the Sequence of Events

The accident began about 4 a.m. on Wednesday, March 28, 1979, when the plant experienced a failure in the secondary, non-nuclear section of the plant (one of two reactors on the site). Either a mechanical or electrical failure prevented the main feedwater pumps—component (1) in the animated diagram—from sending water to the steam generators (2) that remove heat from the reactor core (3). This caused the plant's turbine-generator (4) and then the reactor itself to automatically shut down. Immediately, the pressure in the primary system (the nuclear piping portion of the plant shown in orange) began to increase. In order to control that pressure, the pilot-operated relief valve (5) opened. It was located at the top of the pressurizer (6). The valve should have closed when the pressure fell to proper levels, but it became stuck open. Instruments in the control room, however, indicated to the plant staff that the valve was closed. As a result, the plant staff was unaware that cooling water in the form of steam was pouring out of the stuck-open valve. As alarms rang and warning lights flashed, the operators did not realize that the plant was experiencing a loss-of-coolant accident.

Other instruments available to plant staff provided inadequate or misleading information. During normal operations, the large pressure vessel (7) that held the reactor core was always filled to the top with water. So there was no need for a water-level instrument to show whether water in the vessel covered the core. As a result, plant staff assumed that as long instruments showed that the pressurizer water level was high enough, the core was properly covered with water too. That wasn't the case.

Unaware of the stuck-open relief valve and unable to tell if the core was covered with cooling water, the staff took a series of actions that uncovered the core. The stuck valve reduced primary system pressure so much that the reactor coolant pumps (8) started to vibrate and were turned off. The emergency cooling water being pumped into the primary system threatened to fill up the pressurizer completely—an undesirable condition—and they cut back on the flow of water. Without the reactor coolant pumps circulating water and with the primary system starved of emergency cooling water, the water level in the pressure vessel dropped and the core overheated.
