Federal Office
for the Safety of
Nuclear Waste Management

Fukushima ten years later: The catastrophic accident and its consequences

The Events in Brief

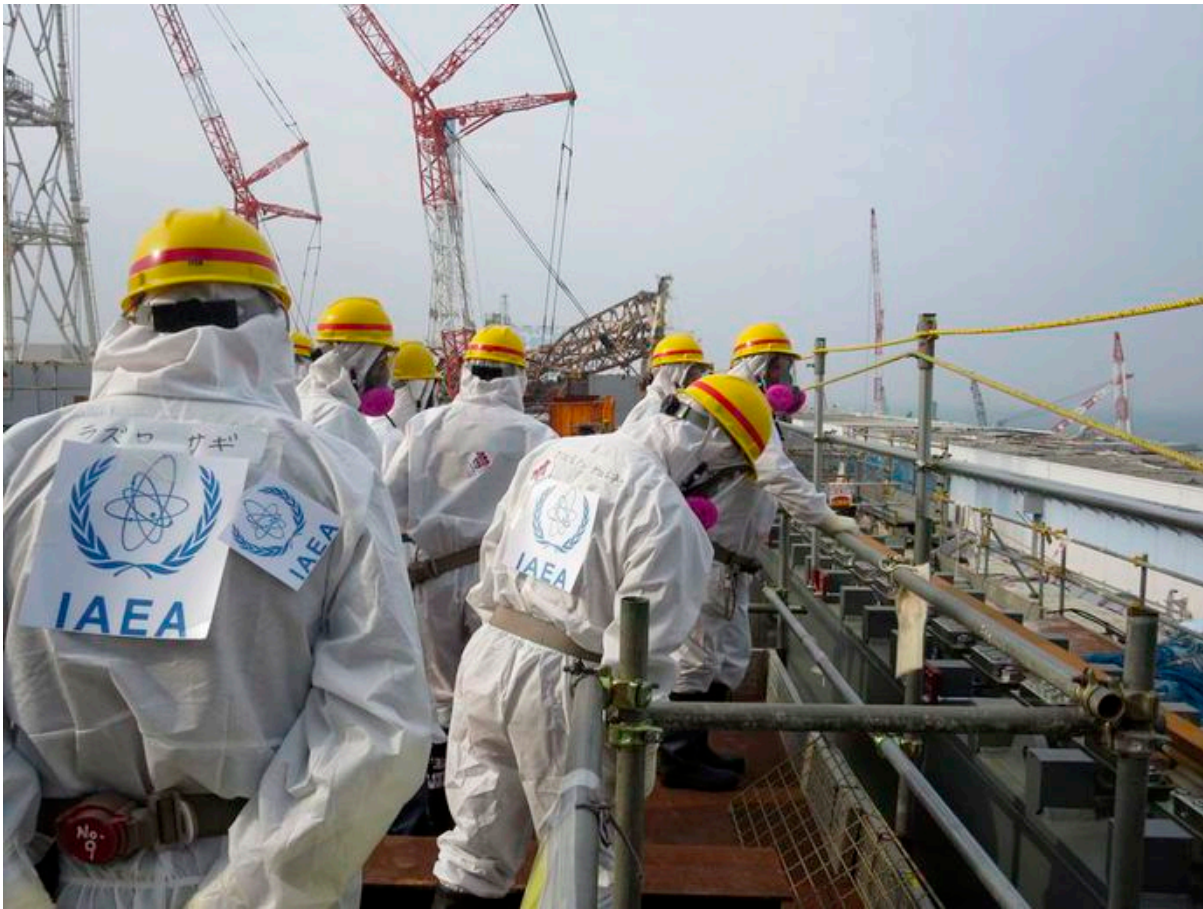
IAEA team inspects the damaged Fukushima Daiichi nuclear power plant

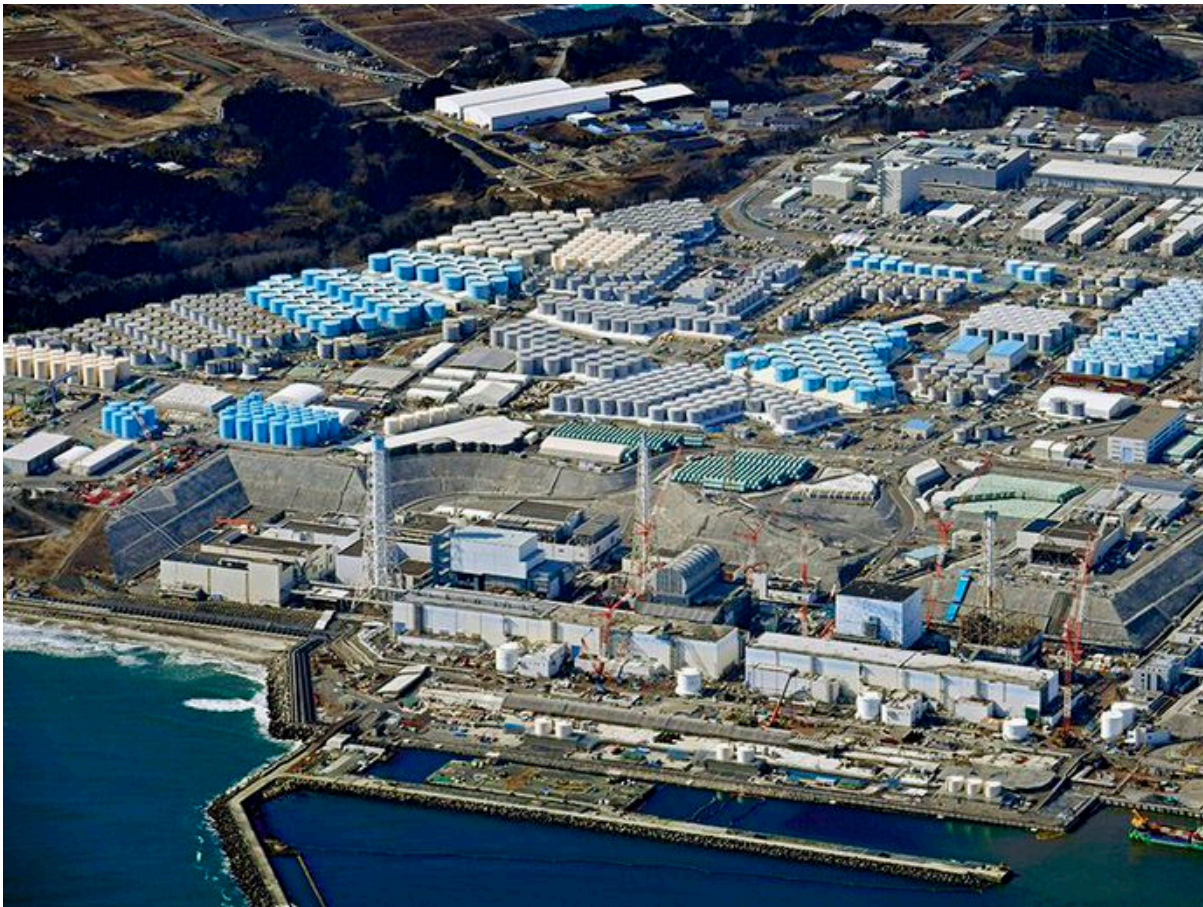
Current aerial view of the Fukushima Daiichi plant (2020)

Since the nuclear accident, the operator [TEPCO](#) has taken extensive measures to keep units 1-4 of the Fukushima Daiichi nuclear power plant in a controlled state and to minimise the [release of radionuclides](#). At the same time, these measures serve to prepare for the [decommissioning](#) of the plant. According to current estimates, the entire [decommissioning](#) process will take 30 to 40 years.
